**FINAL REPORT  
FOR  
TF30 THIRD-STAGE COMPOSITE FAN BLADE  
SERVICE PROGRAM  
Contract No. F33657-70-C-0624**

David G. Randall  
Pratt & Whitney Aircraft Group  
United Technologies Corporation  
East Hartford, Connecticut 06108

15 May 1978

Final Report for Period 1 July 1970 – 31 December 1977

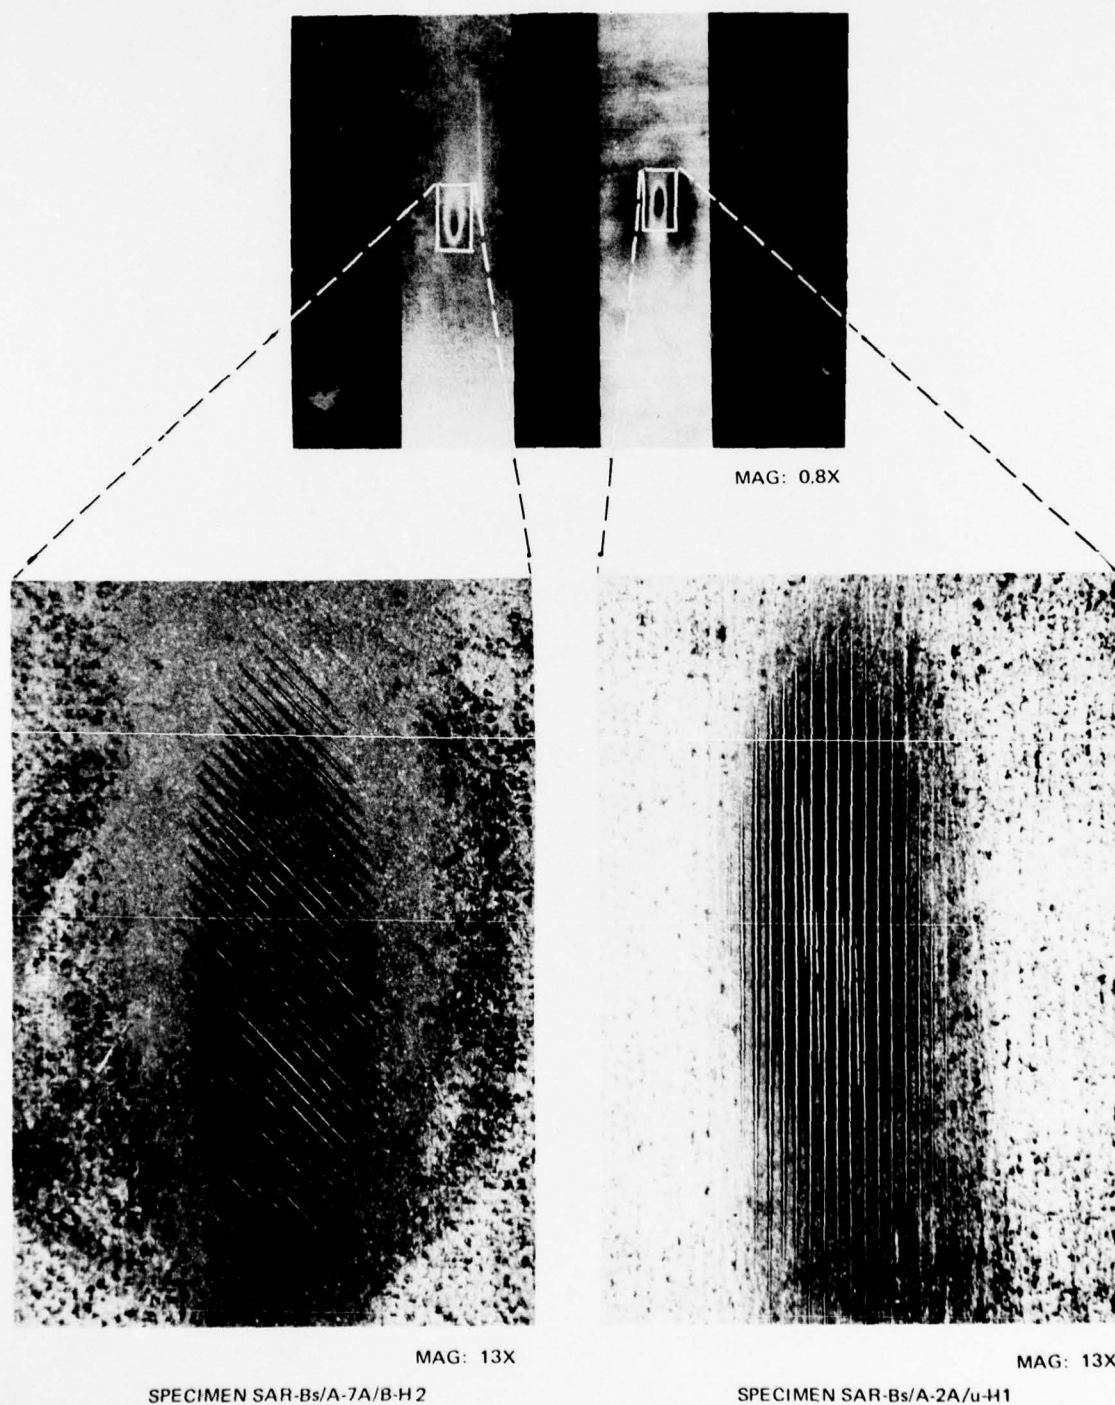
Figure 9.2-2 Typical Erosion Effect on 20-Layer Borsical<sup>®</sup> Test Panels of a Nine-Second Exposure to 0.14 g/sec Flow of 27-Micron Alumina in 60 psig Air at an Impingement Angle of 20 Degrees

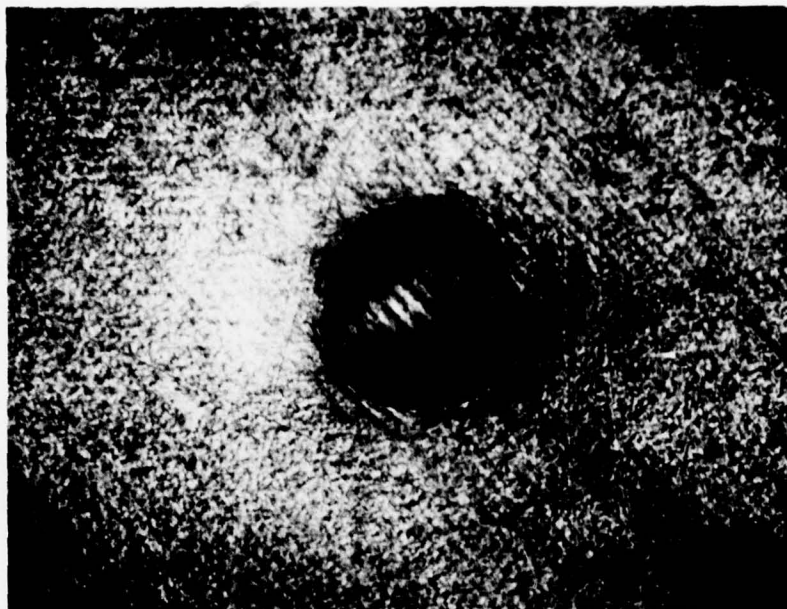
*Figure 9.2-3 Ballistic Impact Damage on a Unidirectional Borsical<sup>®</sup> Test Panel Specimen, SAR-Bs/A-3A/u-H2*

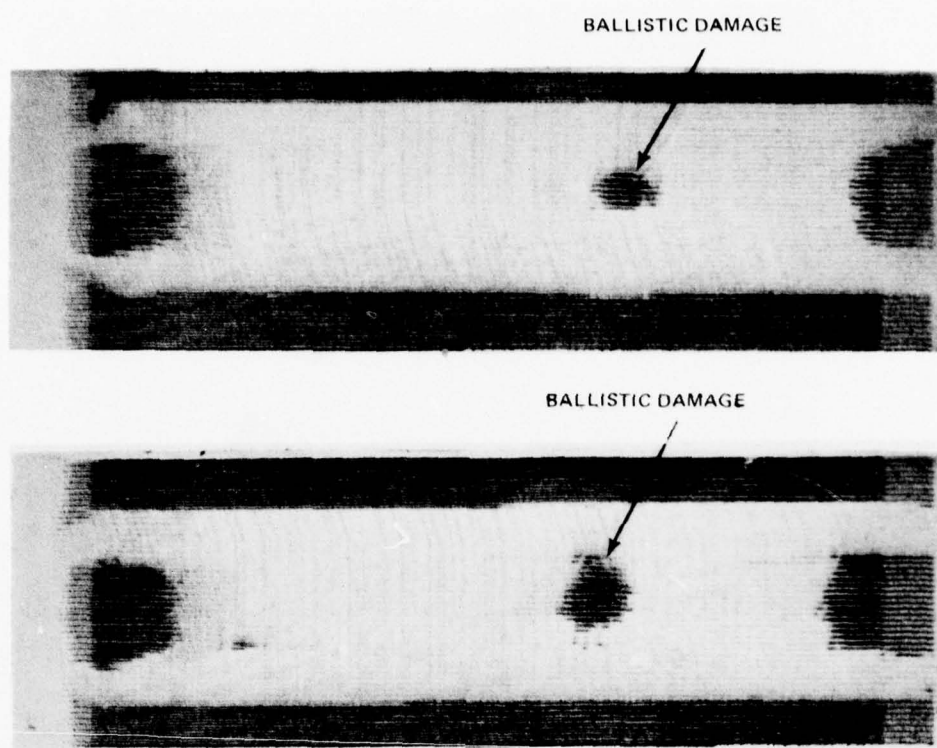
*Figure 9.2-4 Ballistic Impact Damage on a Component Borsical<sup>®</sup> Test Panel Specimen, SAR-Bs/A-7B/B-H3*

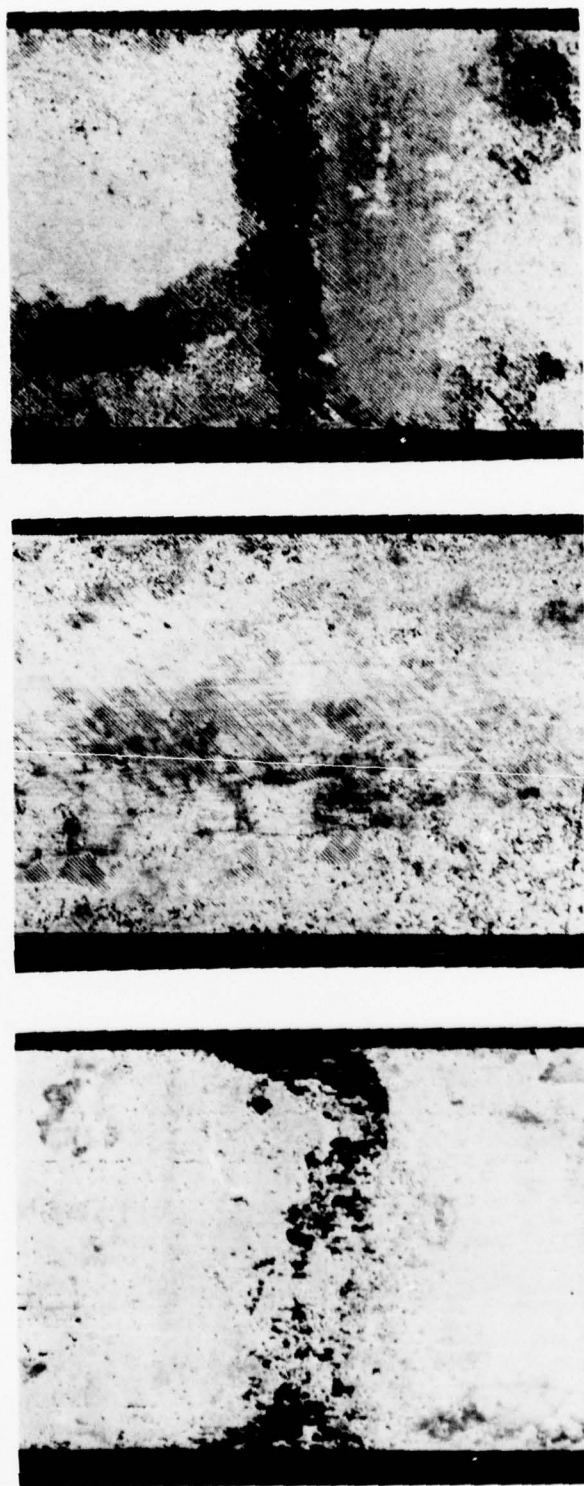
*Figure 9.2-6 Typical Corrosive Effect on 20-Layer Borsical<sup>®</sup> Test Panels of a 100-hour Exposure to a Humid Salt Spray; Maximum Strain at Fulcrum of the Test Fixture was 1880 microinches which is Equivalent to a Bending Stress of 60,000 psi for the Unidirectional Specimens and 35,000 psi for the Component Specimens*

Figure 9.2-7 Surface Appearance of Unidirectional, Component, and Cross-Ply (Left to Right, Respectively) Borsical® Specimens After 100-hour Salt Stress-Corrosion Exposure

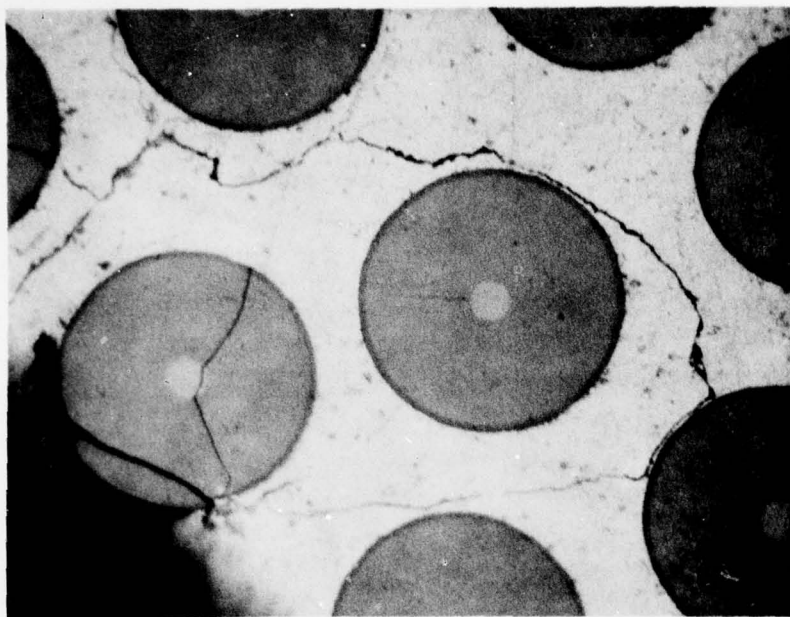
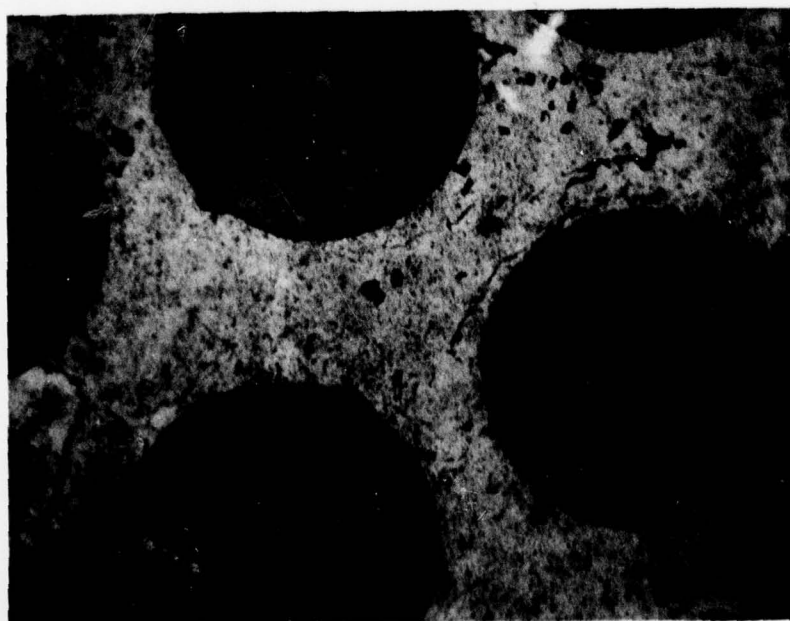
Room temperature HFF tests of unidirectional specimens resulted in microstructures of several distinct types. When run at low strain levels ( $< 2400 \mu\text{in./in.}$ ), no fatigue cracks or delaminations were observed. Between 2400 and approximately 3000  $\mu\text{in./in.}$  strain, the unidirectional specimens that were tested to  $10^7$  cycles developed internal fatigue cracks of the type shown in Figure 9.4-3 with no visible specimen delamination or appreciable frequency drop. Note that the cracks are not associated with the fiber-matrix and the ply-to-ply interfaces, indicating good bonding during panel fabrication. Specimens cycled at approximately 3100  $\mu\text{in./in.}$  and higher for up to  $5 \times 10^6$  cycles revealed that surface delamination occurred at about  $3 \times 10^6$  cycles with severe matrix and fiber damage near the specimen surface, as shown in Figure 9.4-4. Delamination with very few fatigue cracks and no significant natural frequency drop was detected in specimens tested at high strains (greater than 3400  $\mu\text{in./in.}$ ) for short times. An additional type of deterioration observed after testing at 3100  $\mu\text{in./in.}$  consisted of internal delamination between the ninth and tenth layers of the 20-layer composite, as shown in Figure 9.4-5. No fiber splitting was observed in any unidirectional specimens examined after room temperature HFF tests.

Figure 9.4-3 Microstructure of Unidirectional Borsical<sup>®</sup> Specimens that were High Frequency Fatigue Tested at 70° F and 2450  $\mu$  in./in. for  $10^7$  cycles (1C/u-H2 at Left) and 2900  $\mu$  in./in. for  $10^6$  cycles (2D/u-H3 at Right)

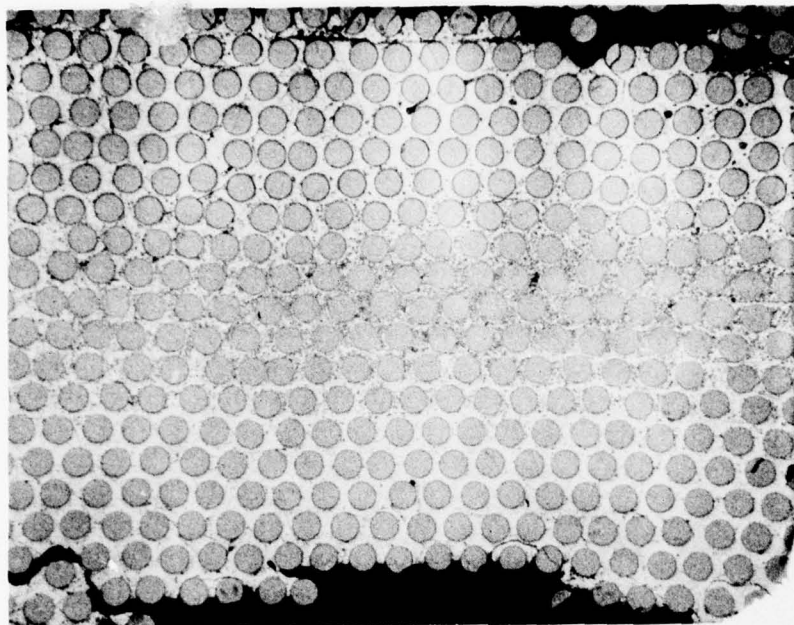
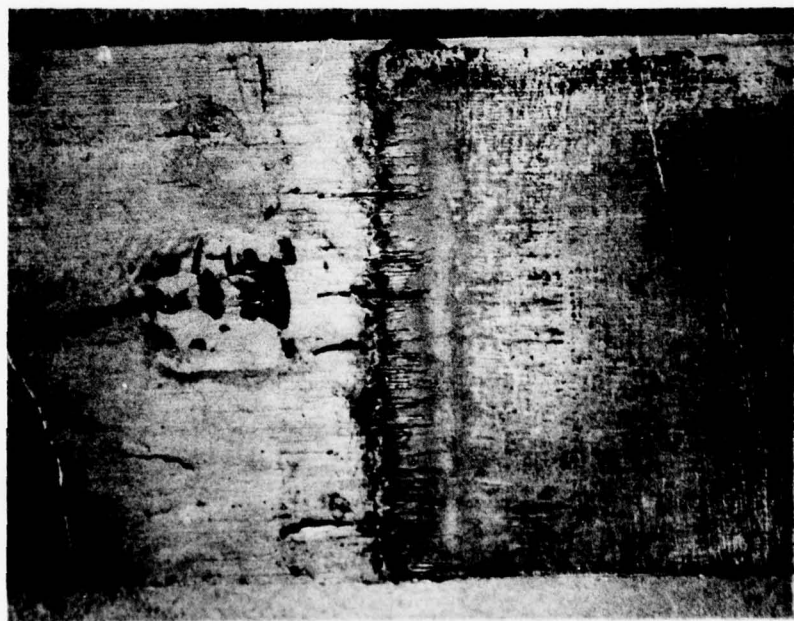
Figure 9.4-6 Surface Appearance and Microstructure of Unidirectional Borsical<sup>®</sup> Specimens that were High Frequency Fatigue Tested at 450°F and 2180  $\mu$  in./in. for  $10^6$  Cycles (11F/u-H1)

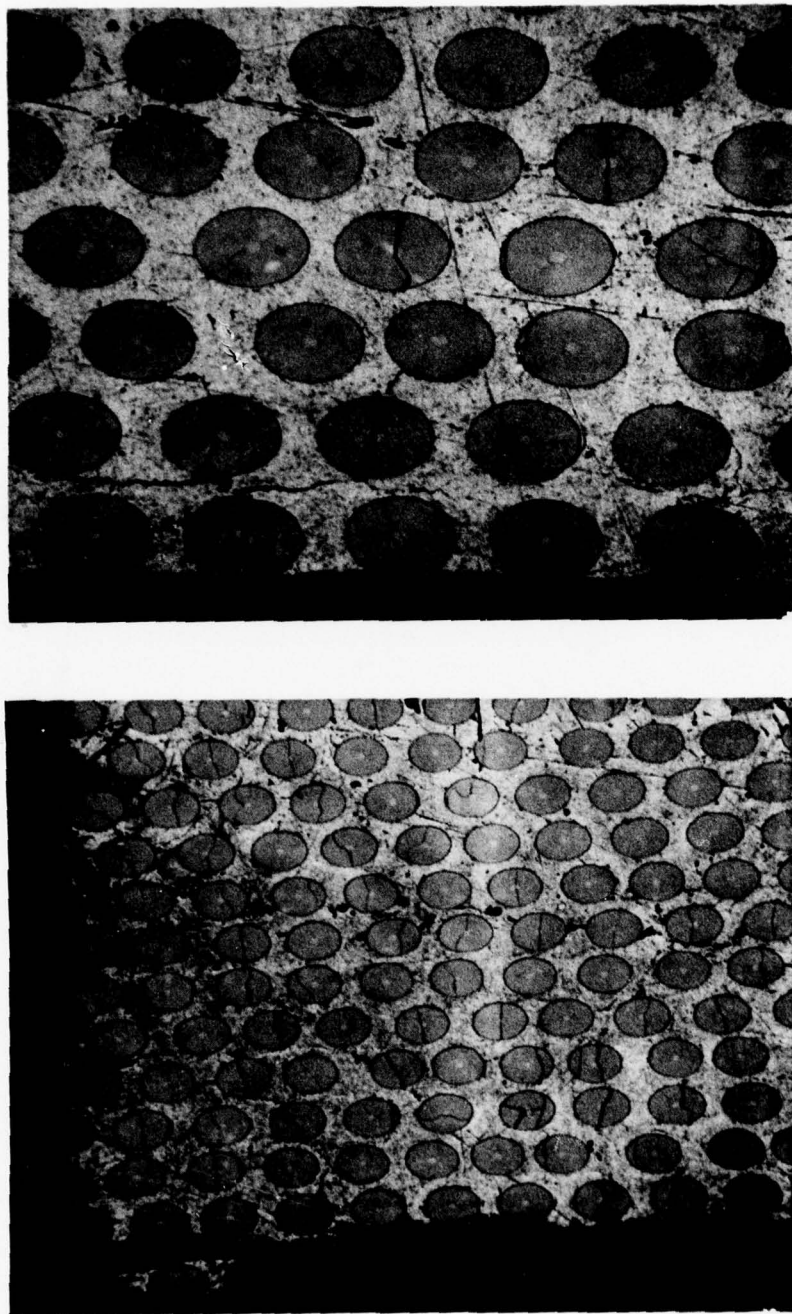
Cross-ply samples that were HFF tested at 450°F contained numerous fatigue cracks which appeared to originate at split fibers (see Figure 9.4-9). The orientation of the splitting which occurred in the fibers of the cross-ply laminate was normal to the plane of the specimens rather than parallel as found in the component specimens. Stress analysis of cross-ply samples during HFF testing indicated that the tensile stresses in the plane of the samples could result in fiber splitting due to the low transverse strength of Borsic® filament. During fatigue testing, a ten percent drop in natural frequency occurred prior to delamination, and apparently the fiber splitting, as well as the growth of fatigue cracks in the matrix, produced that frequency drop. The orientation of fiber splitting directed the fatigue cracks into the specimen, preventing visual delamination.

Figure 9.4-9 Microstructure of Cross-Ply Borical<sup>®</sup> Specimen (12D/C-H4) that was High Frequency Fatigue Tested at 450°F and 1265  $\mu$  in./in. for  $10^7$  Cycles

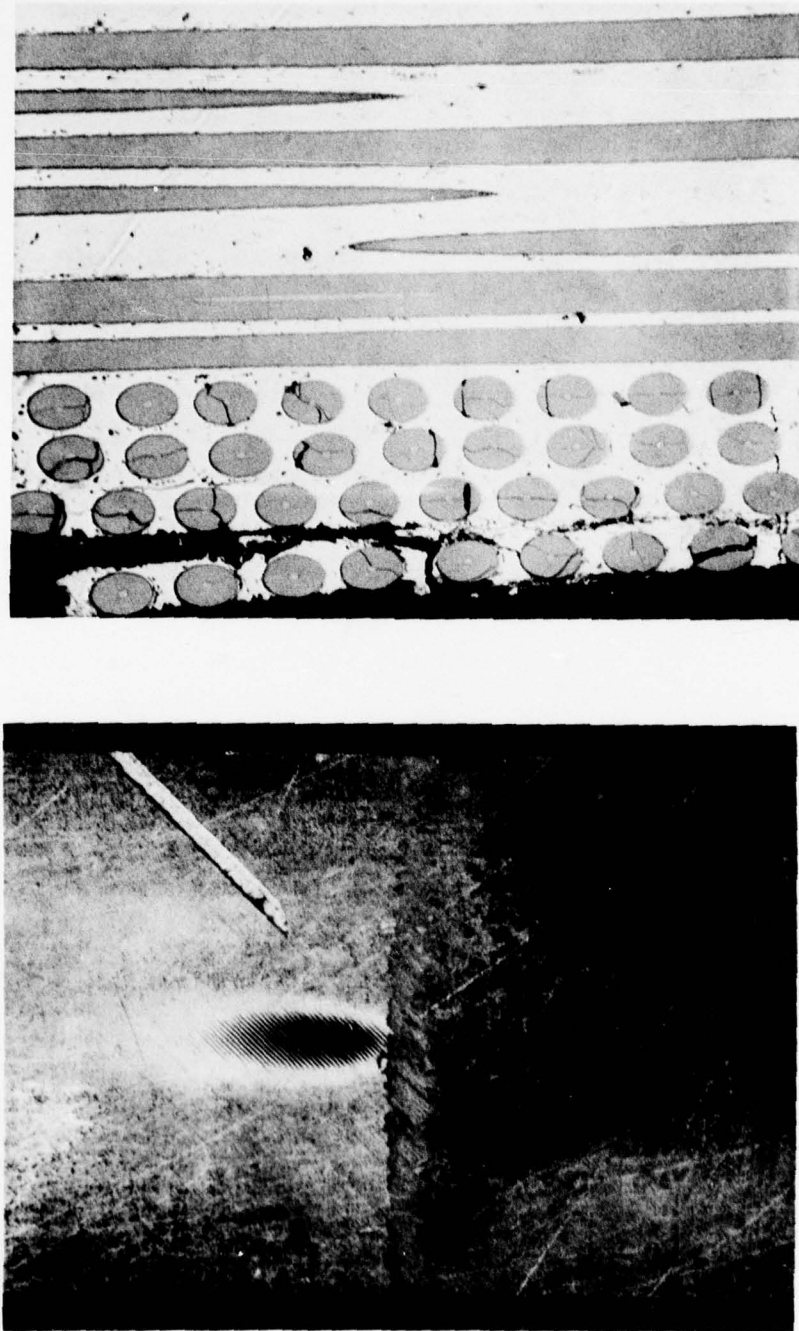
Figure 9.5-4 Surface Appearance and Microstructure of Eroded Component Specimen (7A/B-H2) After 450° F High Frequency Fatigue Testing at 1575  $\mu$  in./in. for  $5 \times 10^6$  Cycles

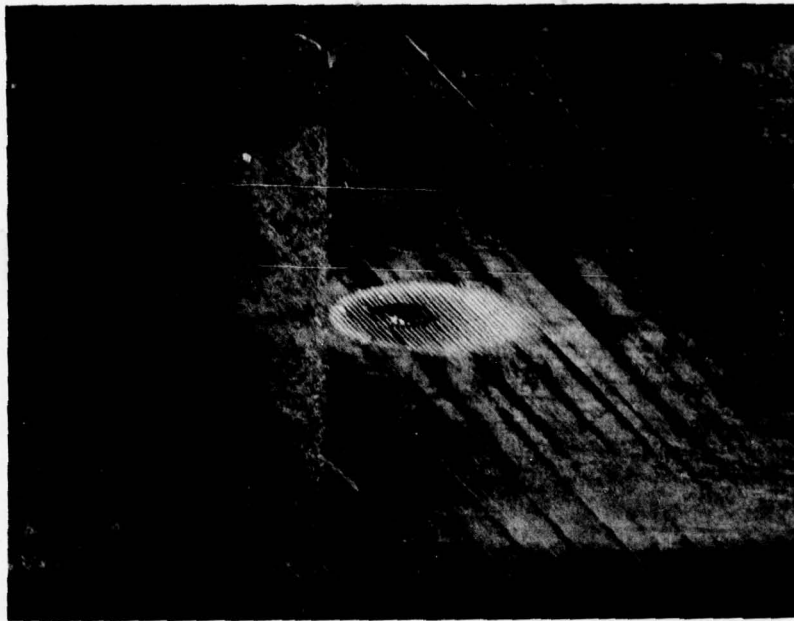
The microstructure of eroded (exposed fibers) 70°F HFF-tested unidirectional specimens was similar to that for undamaged specimens. As shown in Figure 9.5-2, failure takes place by surface delamination with no internal fatigue cracks. Eroded unidirectional specimens HFF-tested at 450°F also looked identical to the undamaged specimens. The delamination did not occur preferentially at the eroded region even when cycled to 100 percent of life expectancy at either room temperature or 450°F. A deeply eroded sample with broken fibers was HFF tested at 450°F and did delaminate from the damaged area as shown in Figure 9.5-3. Erosion damage also did not alter the failure mode for component specimens. As with undamaged specimens, the 450°F HFF test resulted in splitting of the cross-ply layers and surface delamination as shown in Figure 9.5-4. It should be noted that, again, delamination did not originate in the eroded area of exposed fibers. A deeply eroded component specimen (fibers broken during erosion) behaved in a 450°F HFF test as though there were no broken fibers, and specimen delamination did not begin at the eroded area, as shown in Figure 9.5-5.

*Figure 9.5-5 Surface Appearance of Deeply Eroded Component Specimen (4D/B-H4) After 450°F High Frequency Fatigue Testing at 1710  $\mu$  in./in. for  $5 \times 10^6$  Cycles*

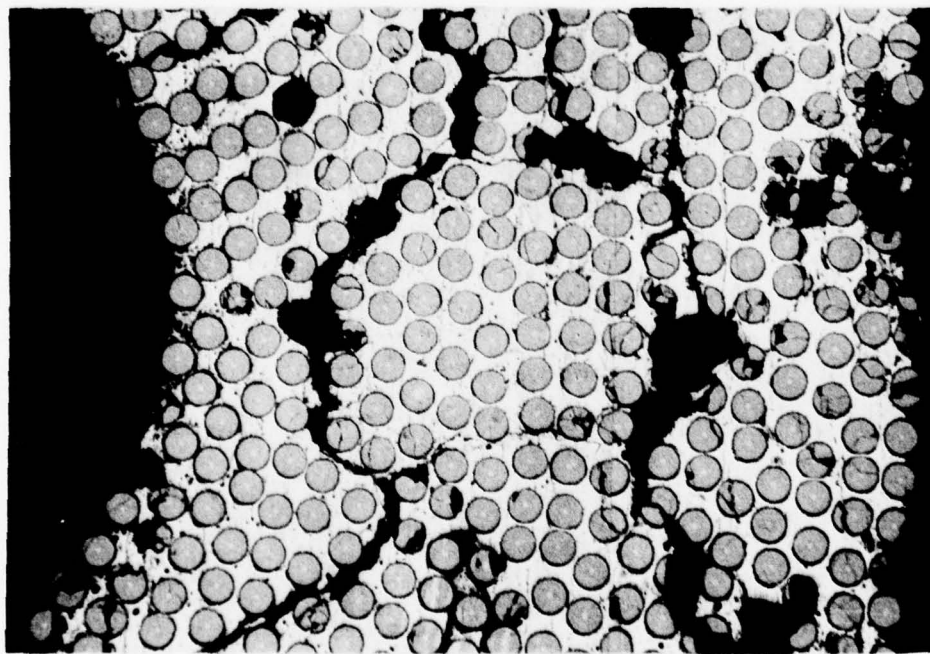
A large amount of matrix cracking was found in the unidirectional specimens after impact, plus 70°F or 450°F HFF testing, as shown in Figure 9.6-4. In contrast, the component specimens which were impacted and HFF tested at 450°F did not contain as much matrix damage as the unidirectional specimens, as shown in Figure 9.6-5. Note that although the cross-ply layers suffered extensive fiber breakage, the unidirectional core fibers remained intact and little matrix cracking occurred. At locations away from the immediate impact area, fiber splitting and surface delamination took place in these component specimens similar to the undamaged specimen behavior, as shown in Figure 9.6-6. Impact plus 450°F HFF damage of cross-ply material is illustrated in Figure 9.6-7. The excessive fiber and matrix damage shown are probably the cause of the early frequency drop observed.

*Figure 9.6-4 Typical Ballistically Impacted Unidirectional Specimen After High Frequency Fatigue Testing Showing Extensive Matrix Cracking*

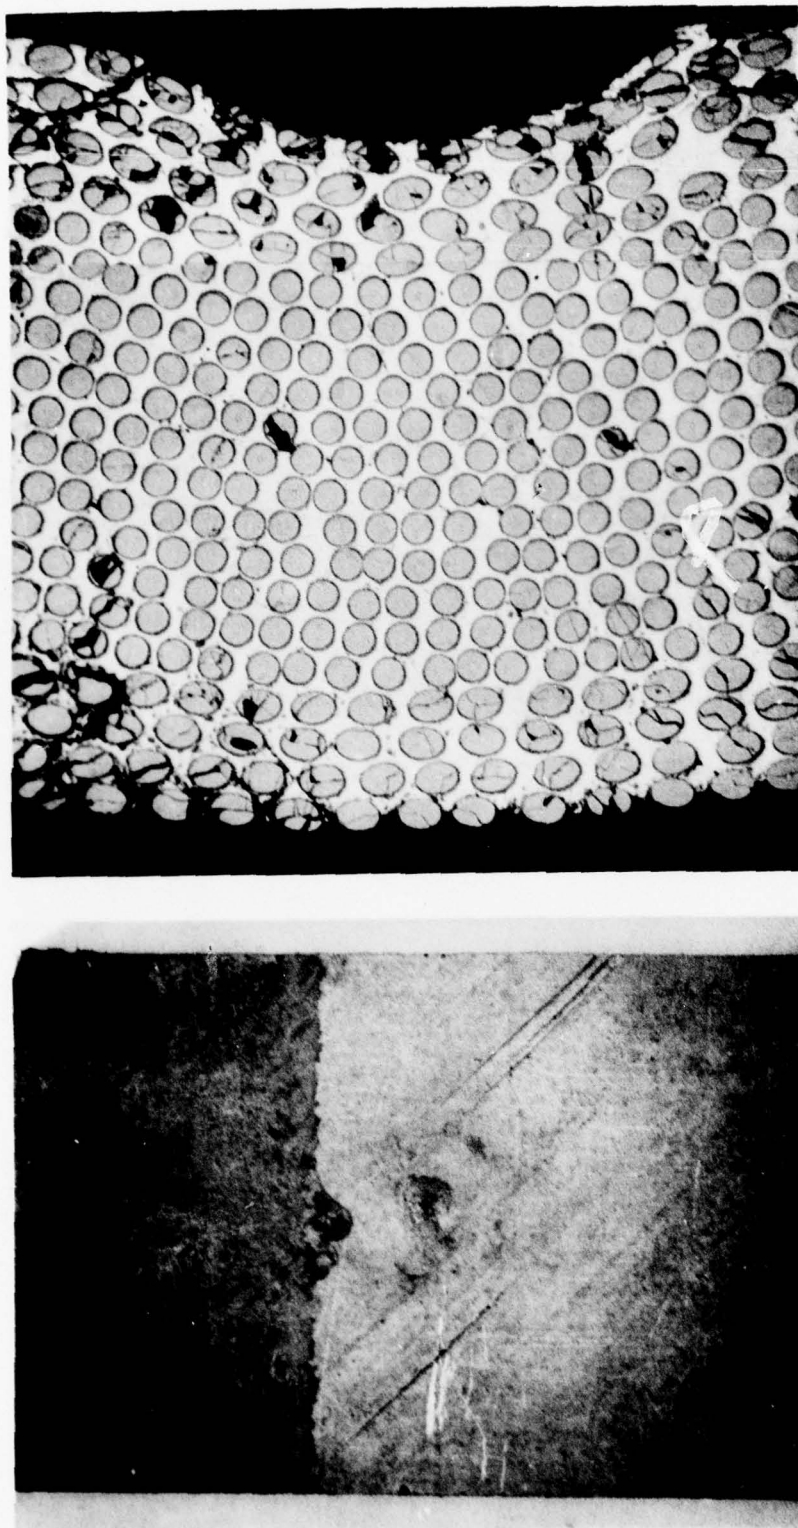
Figure 9.6-5 Typical Ballistically Impacted Component Specimen (7B/B-H4) After High Frequency Fatigue Testing at 450°F: Showing Only Limited Matrix Cracking

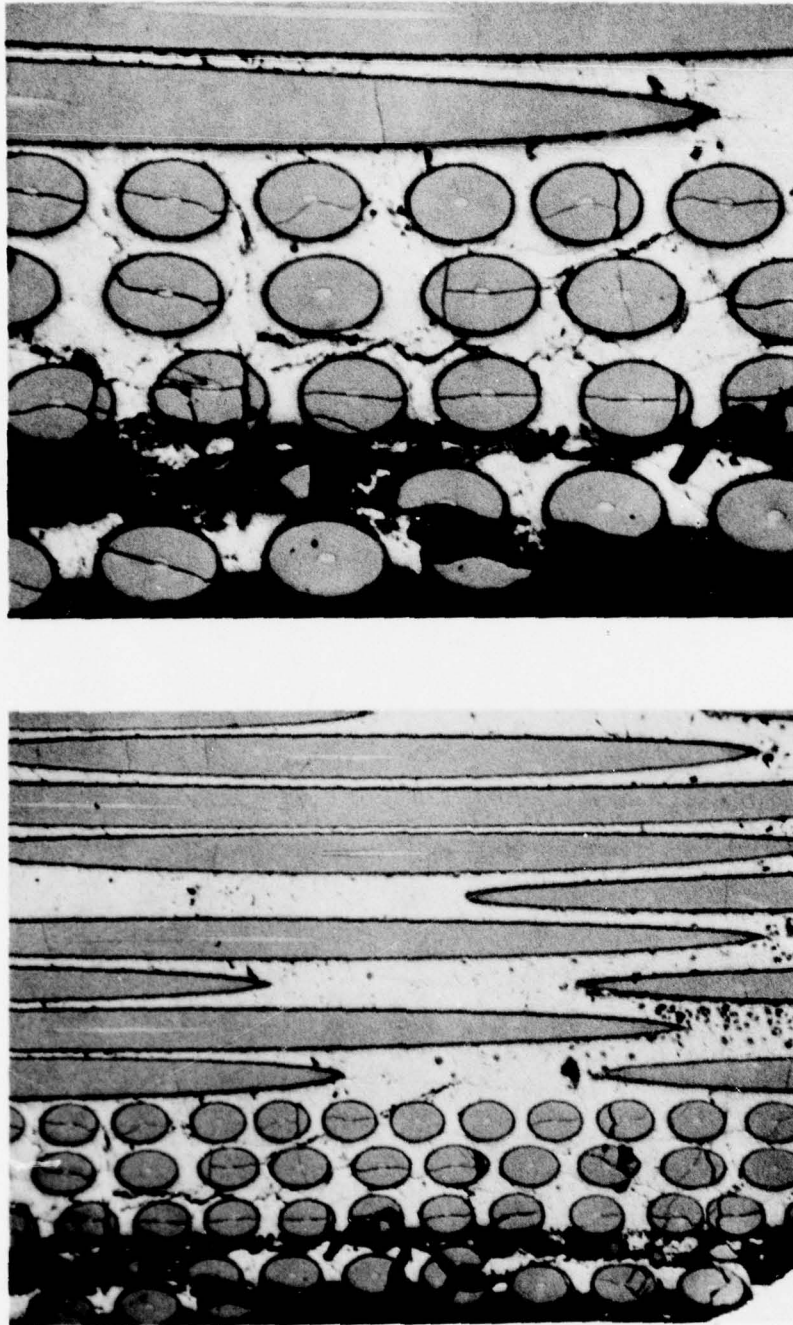
Figure 9. 6-6 Microstructure of Ballistically Impacted Component Specimen (7D/B-H2) After 450°F High Frequency Fatigue Testing

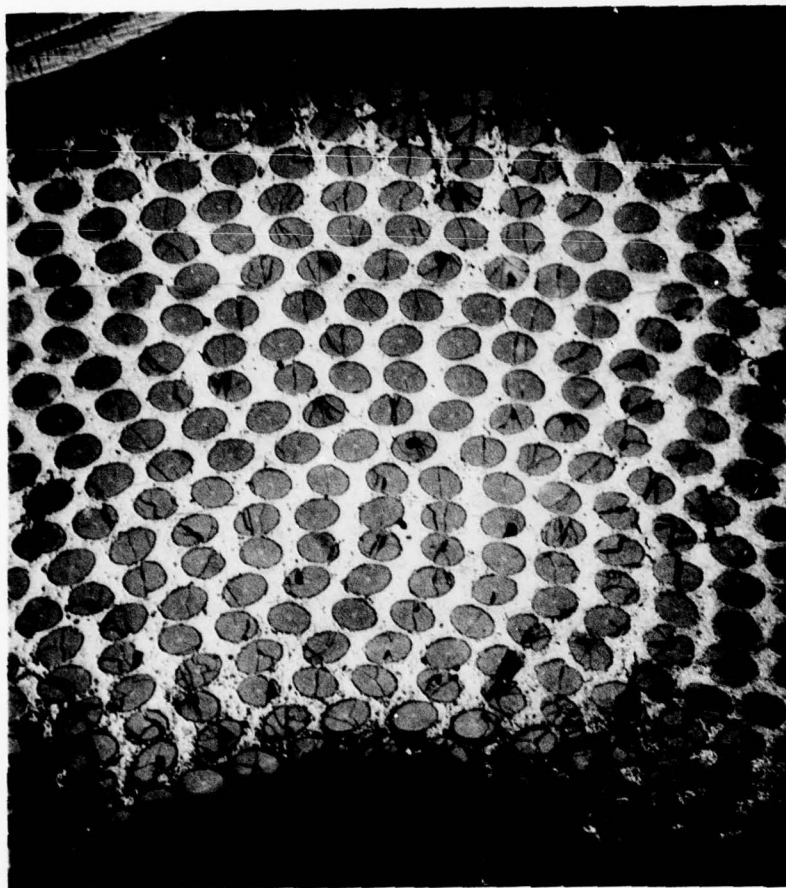
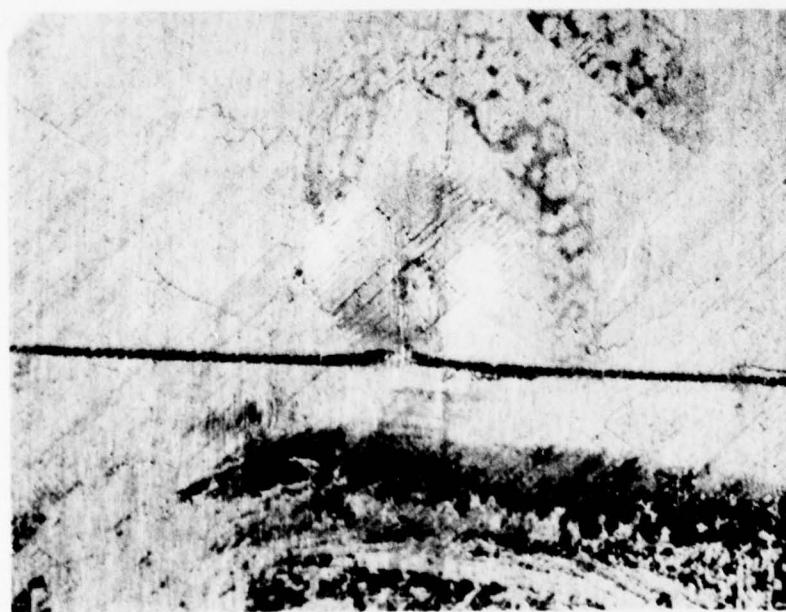
Figure 9.6-7 Ballistically Impacted Cross-Ply Specimen (9E/C-H4) After 450° F. High Frequency Fatigue Testing

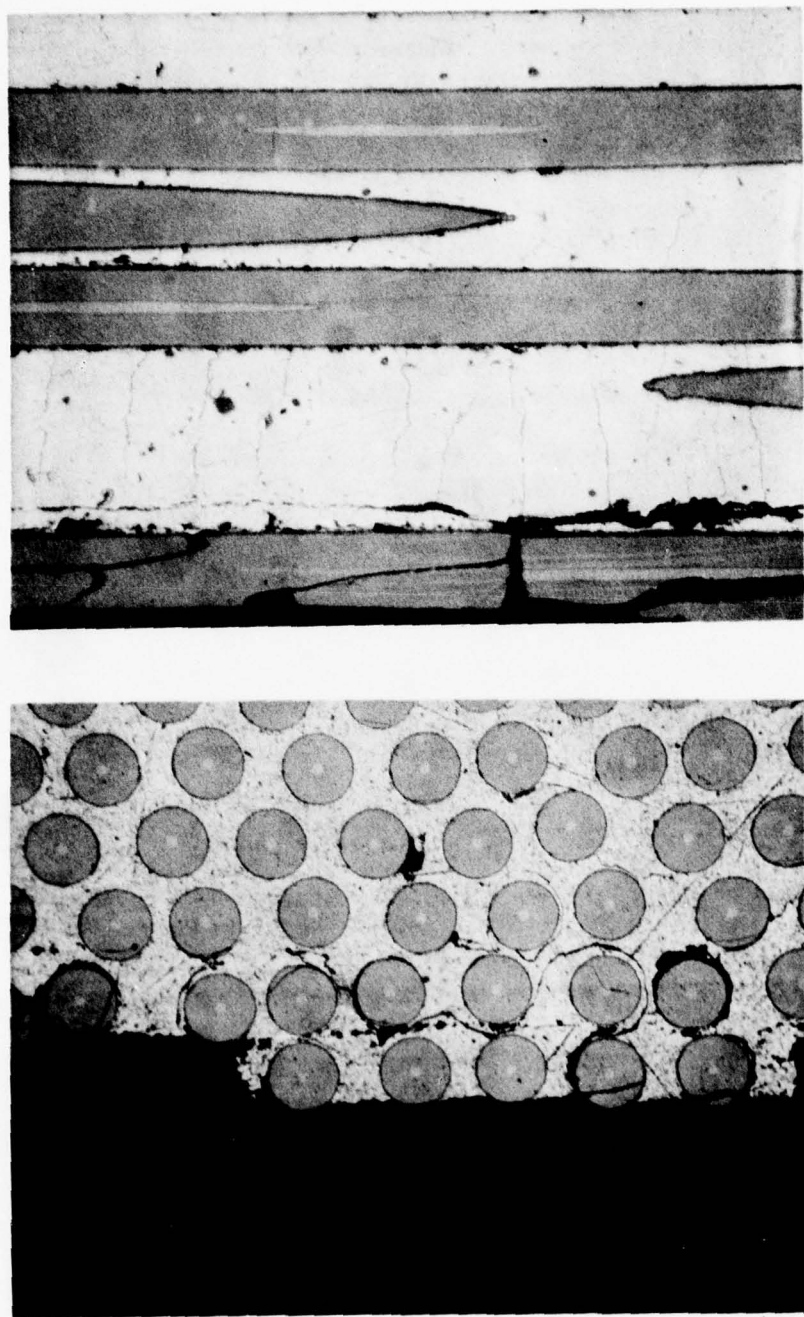
Figure 9.7-2 Microstructure of Thermal Fatigue Damaged Unidirectional Specimen (11A/u-H2)  
After 70°F High Frequency Fatigue Testing

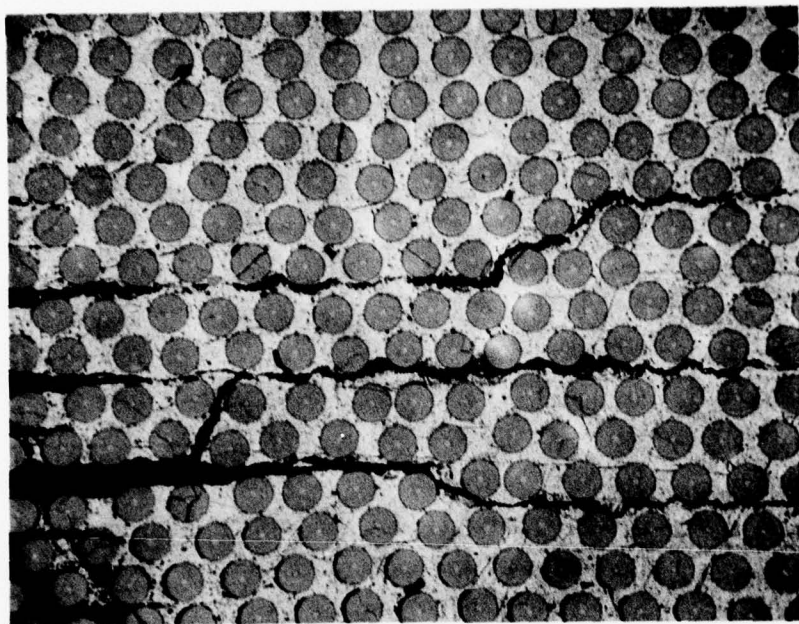
Figure 9.7-3 Surface Appearance and Microstructure of Thermal Fatigue Damaged Unidirectional Specimen (11D/u-H2) After 450° F High Frequency Fatigue Testing

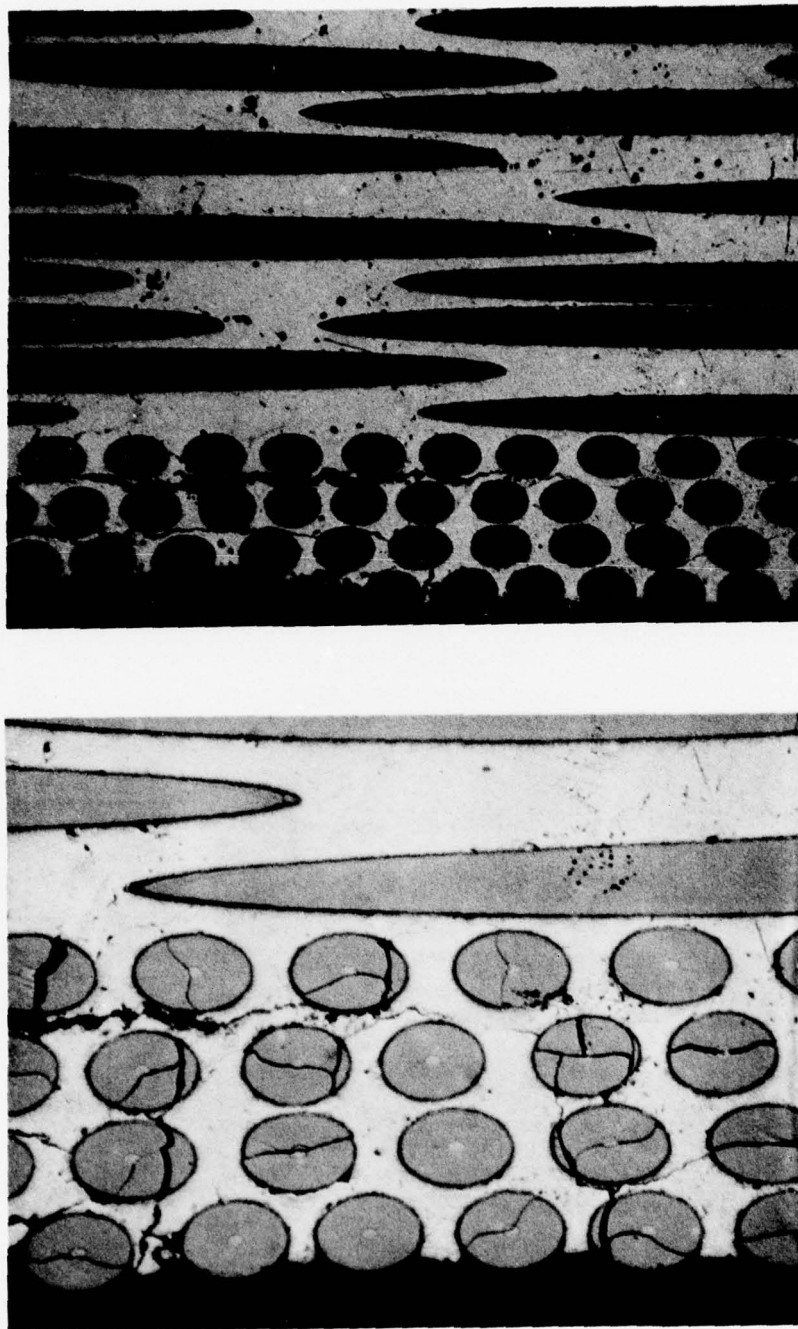
The microstructure of thermal fatigue component specimens looked no different from undamaged specimens after a 450°F HFF test. Failures were characterized by splitting of the cross-ply fibers and surface delamination (Figure 9.7-4) with interconnected fatigue cracks. Cross-ply samples also appeared similar to undamaged specimens with fiber splitting normal to the specimen surface.

Figure 9.7-4 Microstructure of Thermal Fatigue Damaged Component Specimen (8B/B-H1)  
After 450°F High Frequency Fatigue Testing

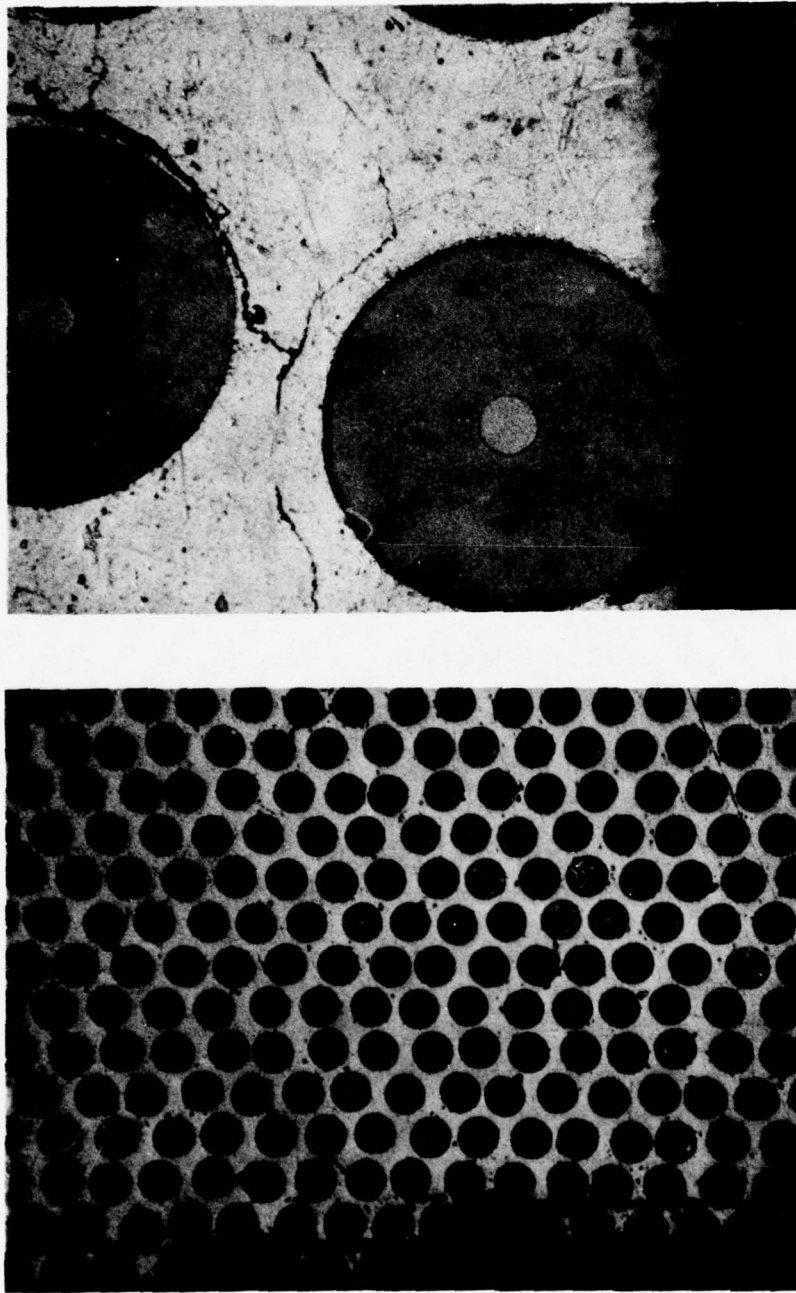
*Figure 9.8-2 Microstructure of Salt Stress-Corrosion Damaged Unidirectional Specimen (6B/u-H2) After 70° F High Frequency Fatigue Testing*

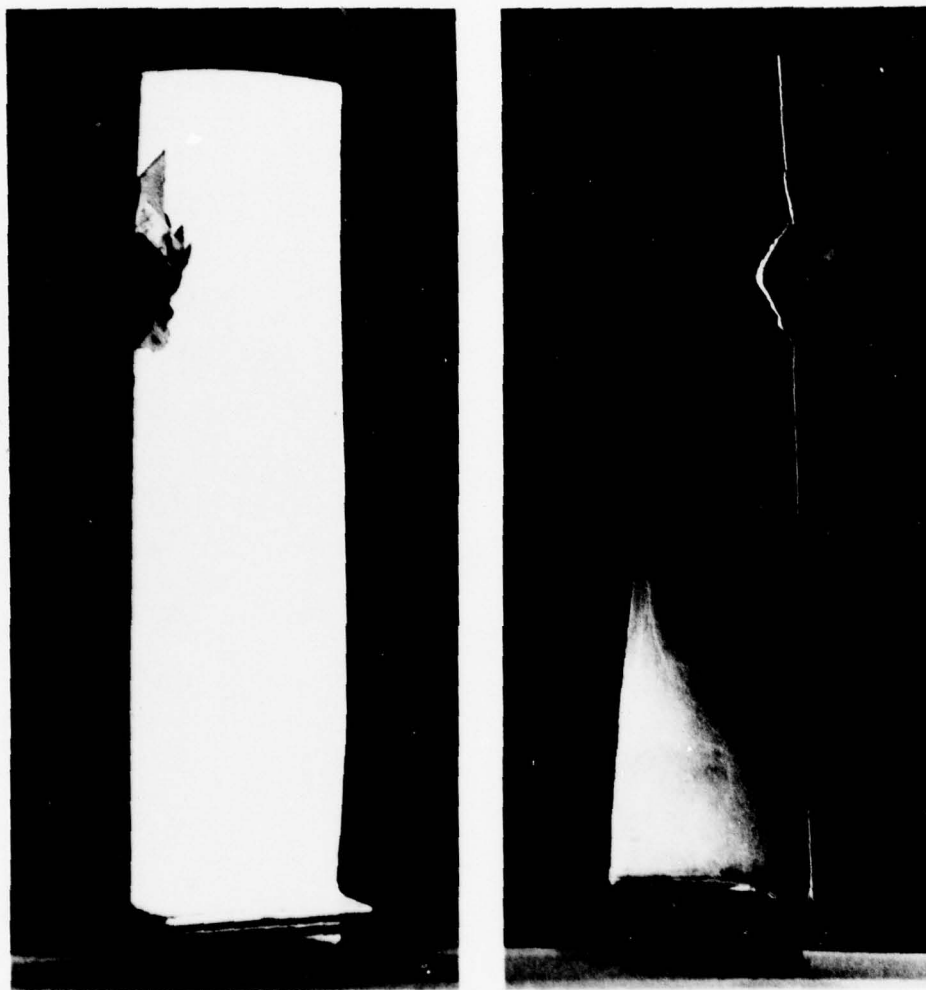
*Figure 10.2-17 Damage Sustained by Blade E-216 After Being Impacted With a Single One-Inch Tempered Ice Ball*

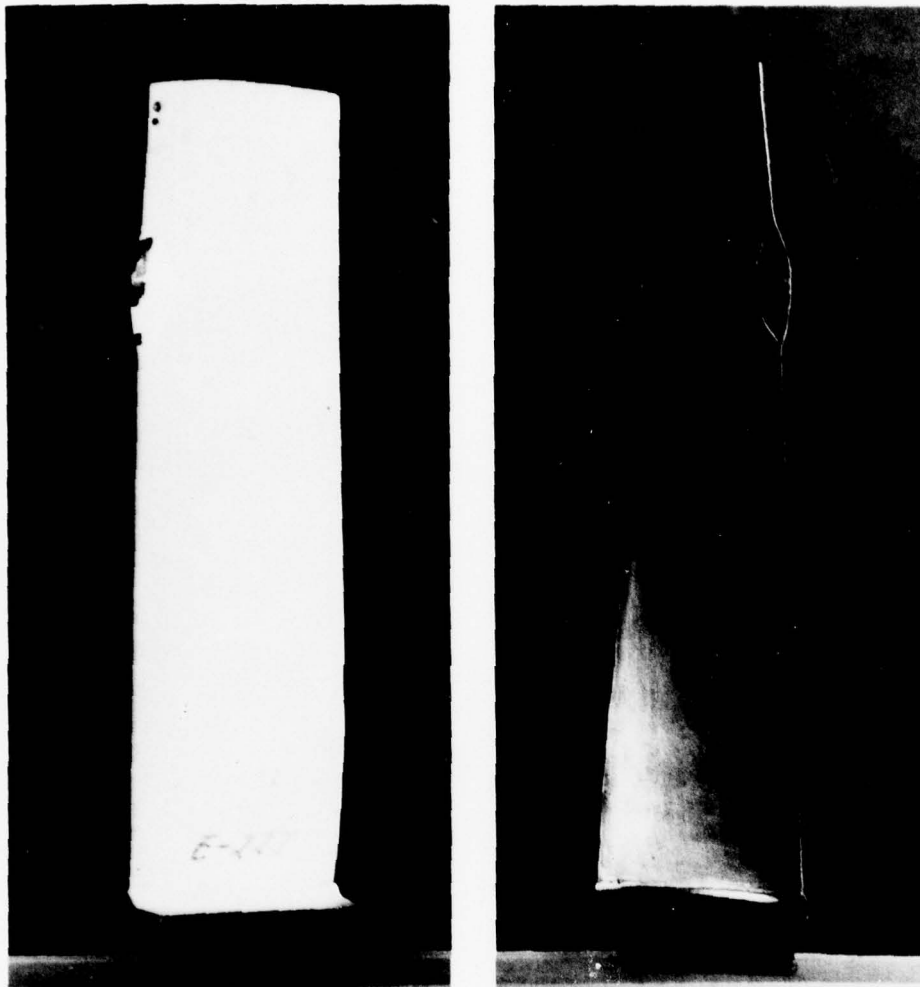
Figure 10.2-18 Blade E-227 Sustained This Damage After Three Impacts of One-Inch Tempered Ice Balls

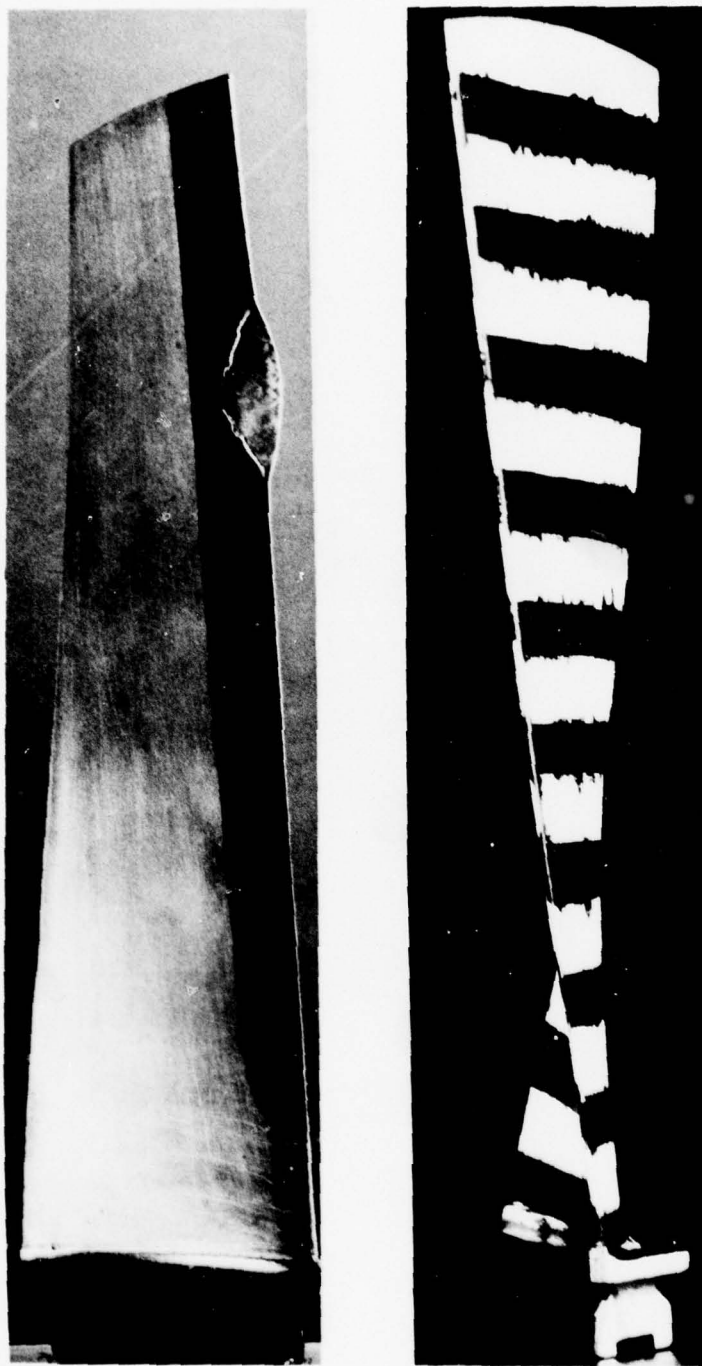
*Figure 10.2-19 The Effect of Leading Edge Thickness on FOD, Blade at Right Had 0.025-Inch L.E. Radius and Sustained Only Slight Dents When Impacted by Six One-Inch Tempered Ice Balls. Blade at left had 0.015-inch L.E. radius and sustained damage shown after three such impacts.*

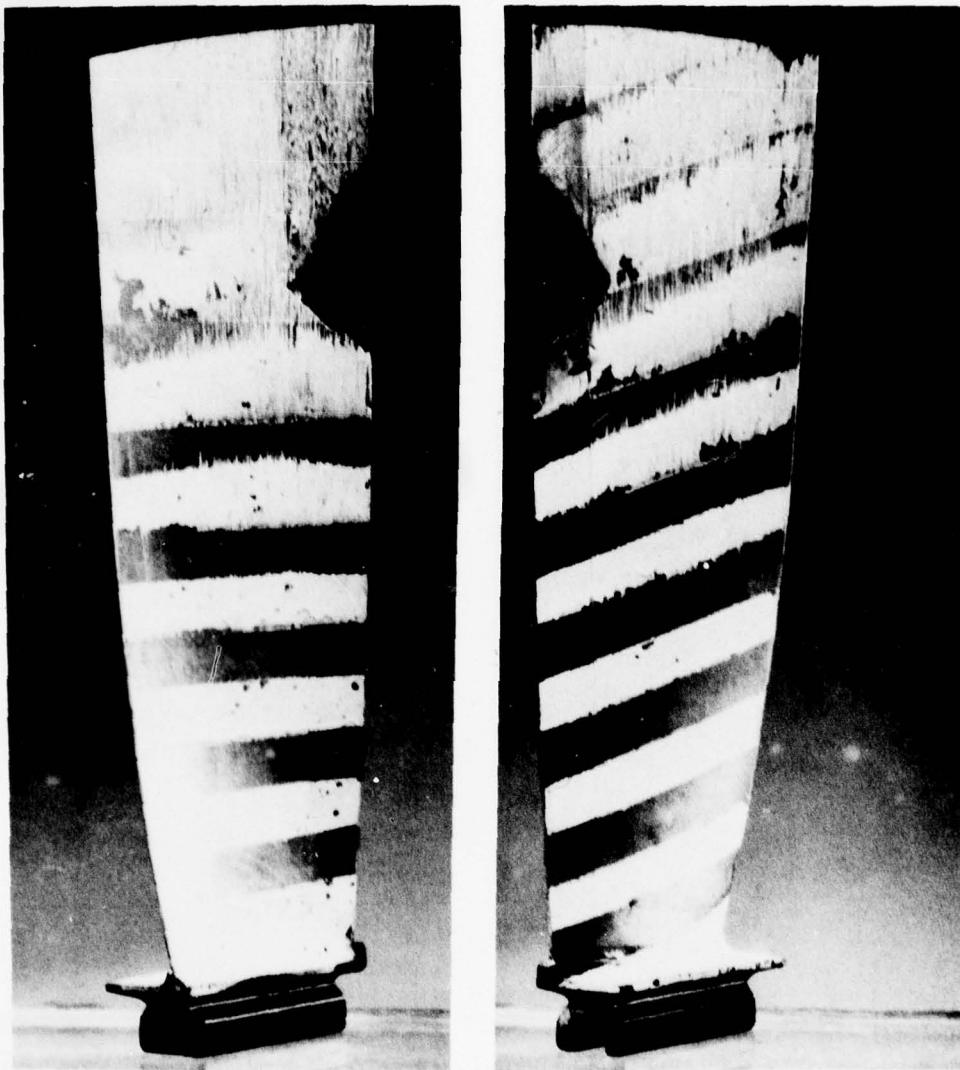
Figure 10.2.21 Damage Sustained by RORSIC<sup>(6)</sup> Aluminum Blade in Massive FOD Test, Projectile was 6-oz. jelly ball

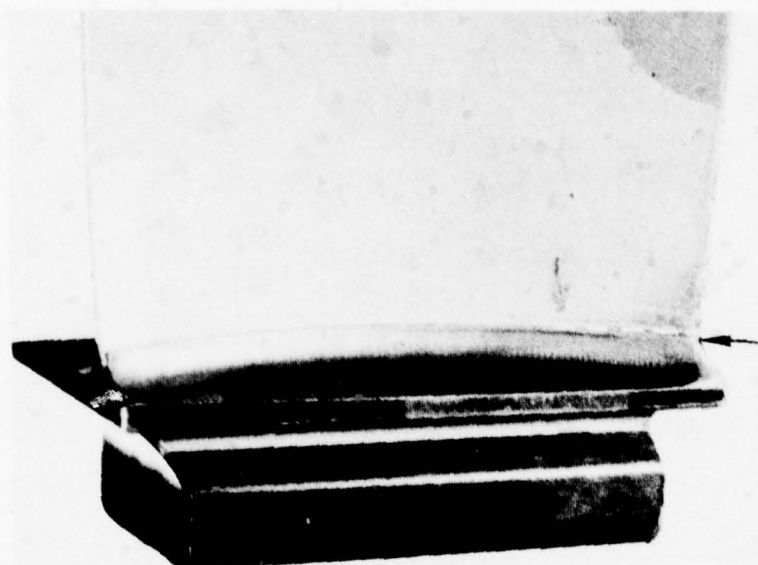
*Figure 11.2-12 Location of Crack at Concave Side of Airfoil Root*
